Geotechnical state-of-the-art in Guatemala -- Ground stabilization

GEOTECHNICAL STATE-OF-THE-ART IN GUATEMALA – GROUND
STABILIZATION

A DISSERTATION

DOCTOR OF ENGINEERING
In
GEOTECHNICAL ENGINEERING

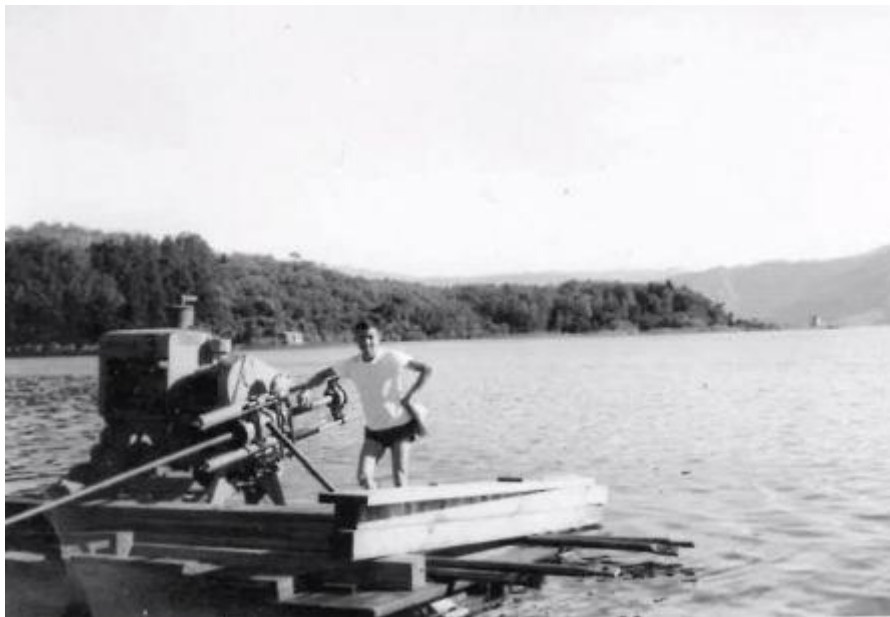
Figure 2.3. Roberto Lou beside a drill ring in 1963, Lake Atitlán, Guatemala

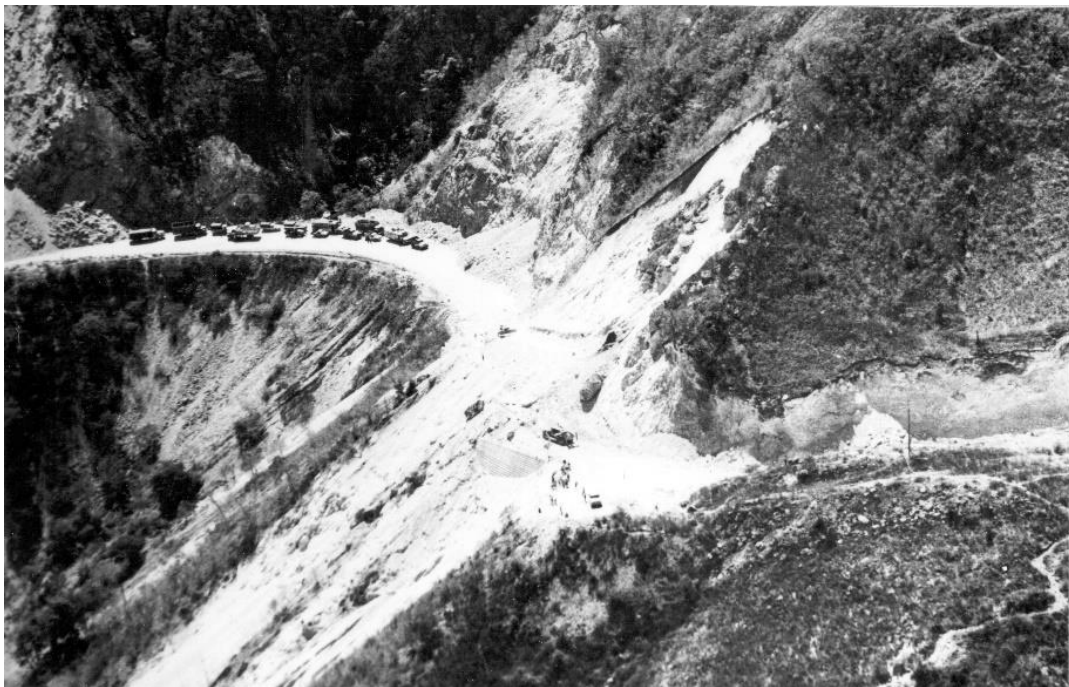
Figure 2.4. One of many landslides blocking the main highway from Guatemala City to El Progreso (Plafker, 1977)

Several geotechnical related failures were observed as landslides, settlements and liquefaction, Figures 2.4 to 2.10 illustrates some of the most critical and representative failures occurred during the earthquake.

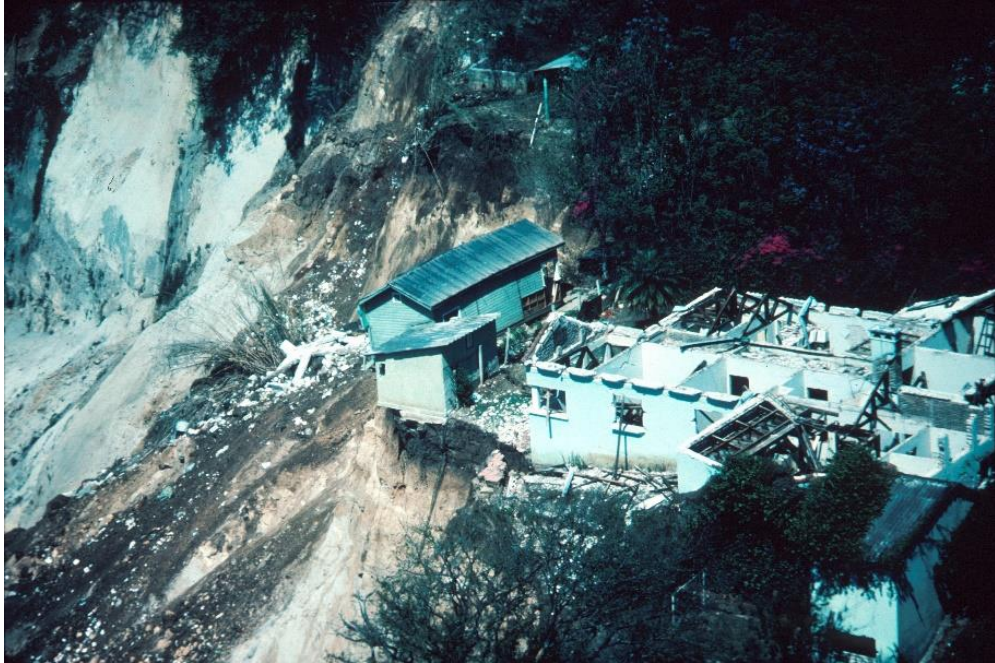
Figure 2.5. Landslide along the edge of a steep walled valley in Guatemala City (Plafker, 1977)

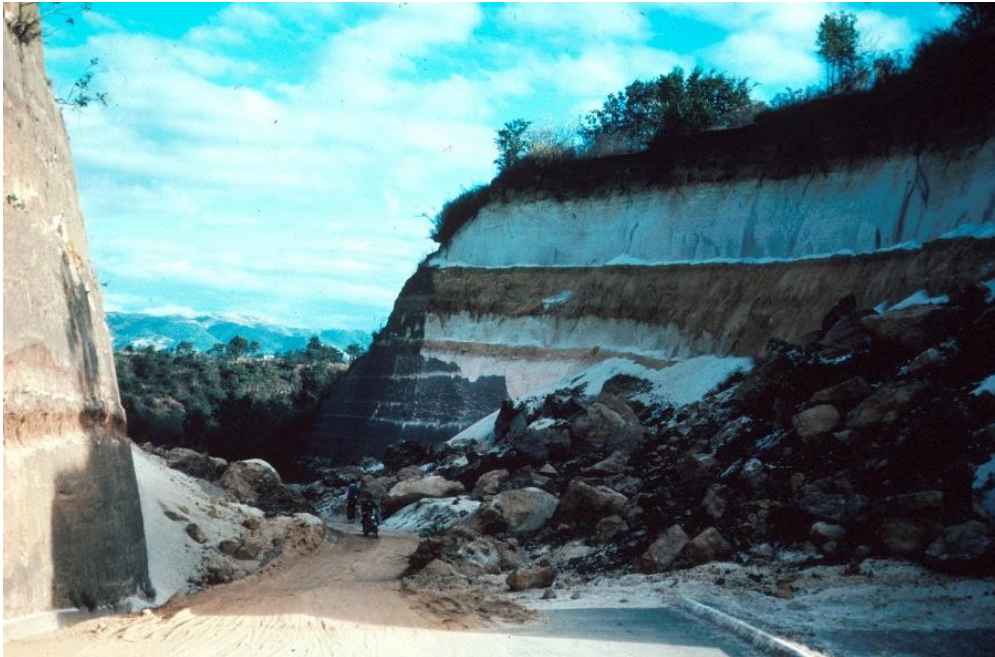
Figure 2.6. Landslides in steep roadcut of stratified pumice and ash deposits at San Cristobal (Plafker, 1977)

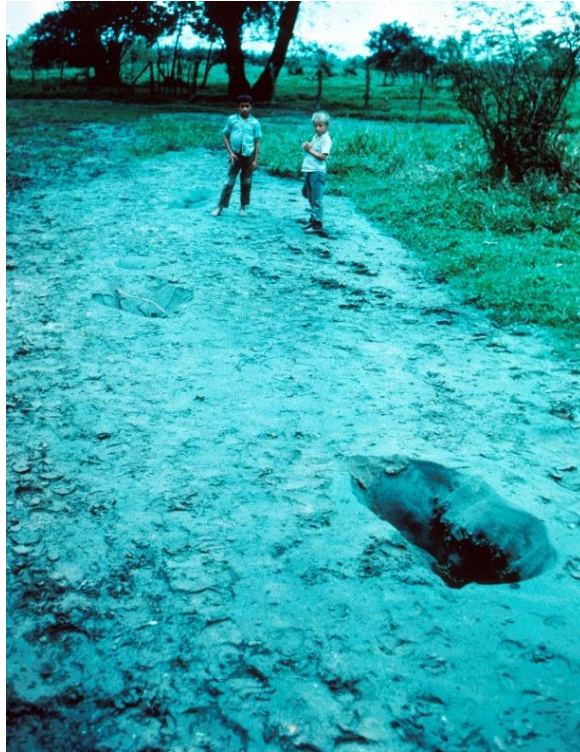
Figure 2.7. Sand mound deposited by a sand blow (Plafker, 1977)

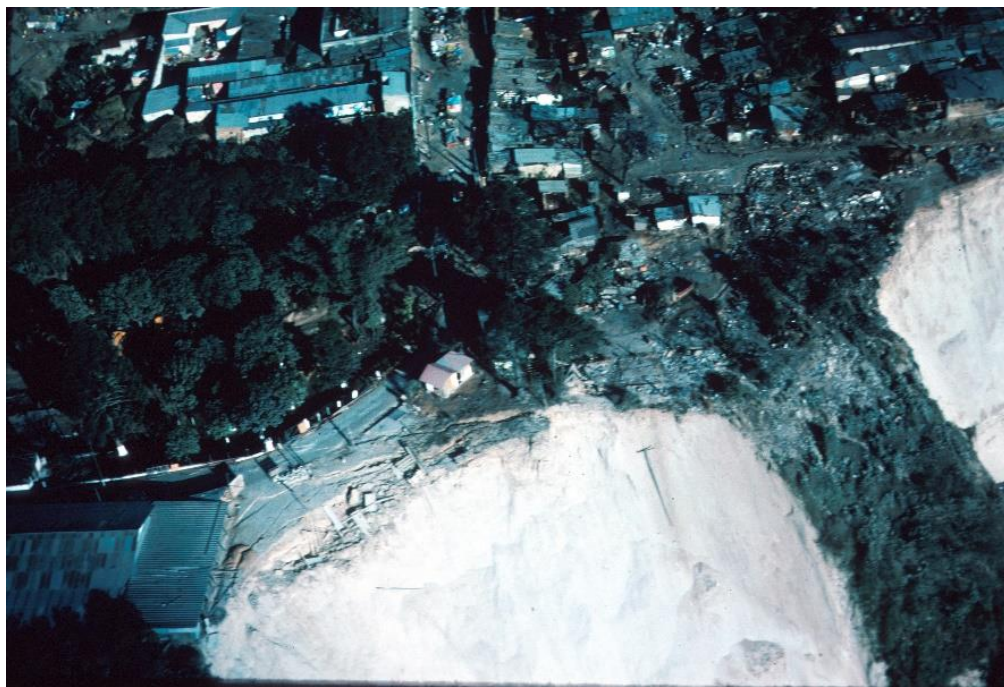
Figure 2.8. Landslides and extensive headwall cracks developed along the edge of a steep walled valley in a Guatemala City suburb (Plafker, 1977)

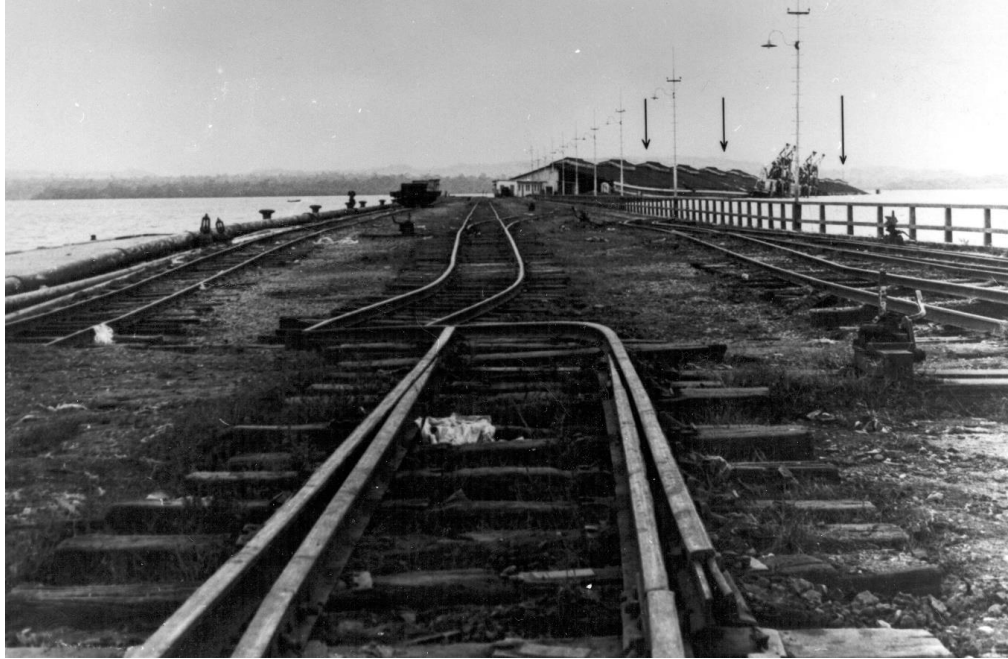
Figure 2.9. Puerto Barrios wharf, destroyed by the February 4 earthquake. Arrows point to the large warehouse partially submerged ((Plafker, 1977)

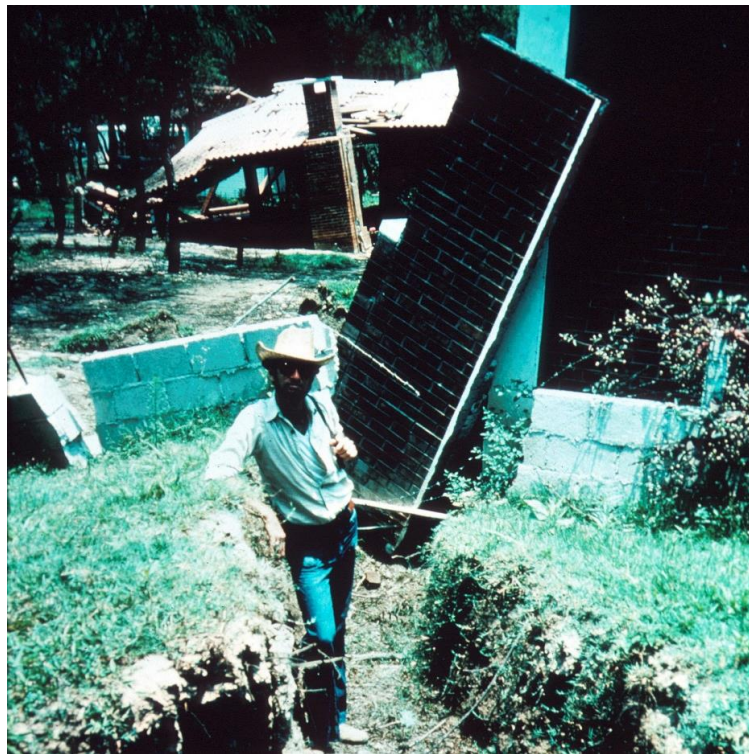
Figure 2.10. Cracks at Lake Amatitlan (Plafker, 1977)

The Figure 2.10. One of many large cracks in a delta at Lake Amatitlan (20 kilometers south of Guatemala City) opened as a result of Earthquake-induced liquefaction of a near surface layer of saturated pumice sand and lateral spreading of the surficial deposits towards the lake. Such cracks caused serious damage where they intersected structures such as the one in the foreground. The front portion of the house in the background sank into the liquefied sand, tilting the brick chimney. (Plafker, 1977)

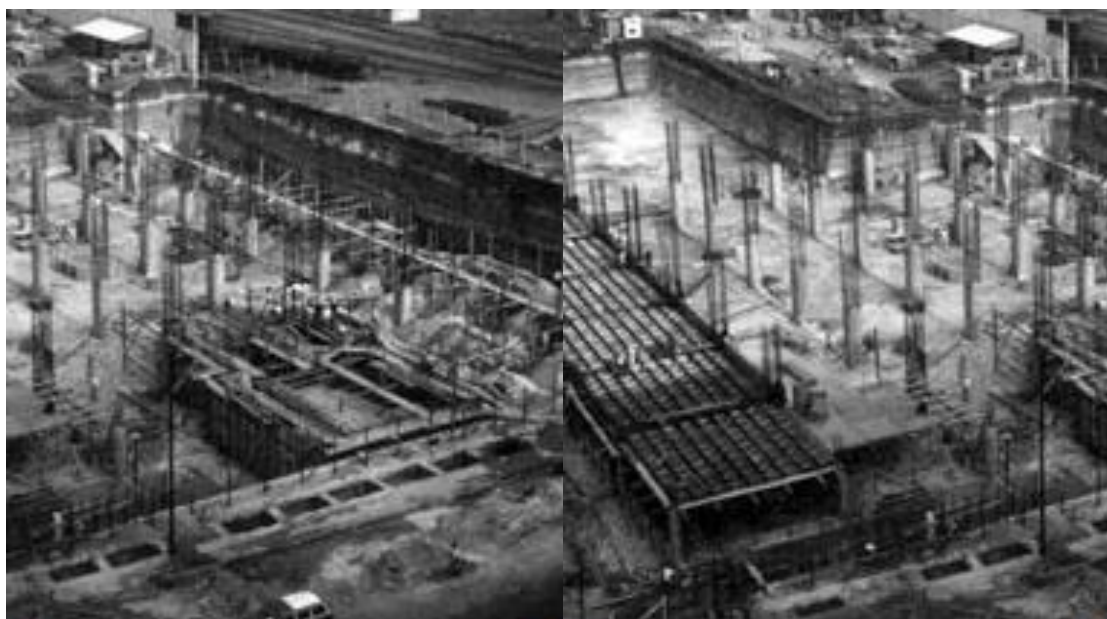
Figure 2.11. Construction of Credito Hipotecario building (Gatonelblu, 2010)

The Figure 2.11 shows images of the construction of Credito Hipotecario building, Figure 2.12 shows Corte Suprema de Justicia building excavation.

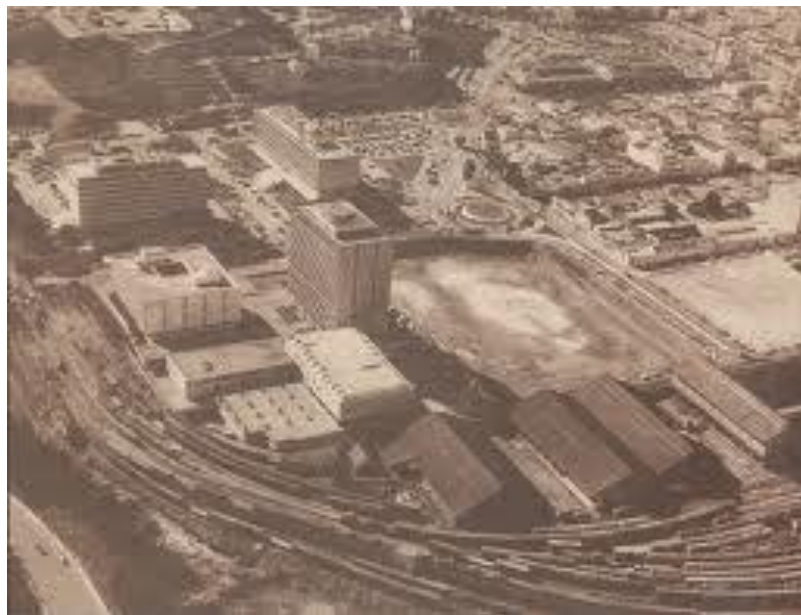
Figure 2.12. Excavation of Corte Suprema de Justicia building (Gatonelblu, 2010)

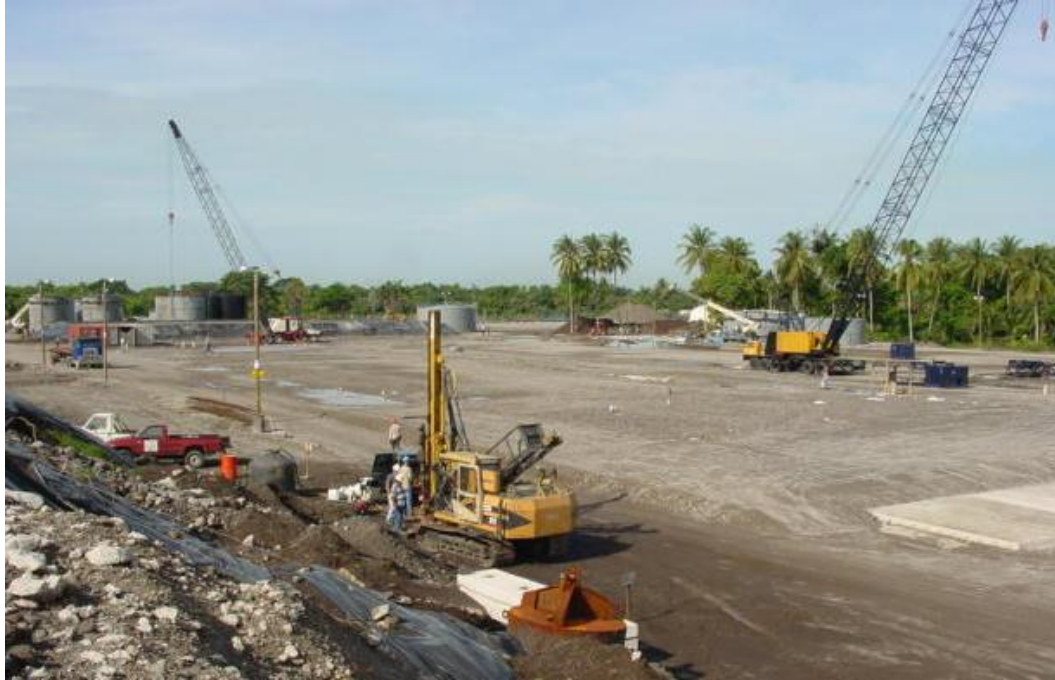
Figure 2.13. Construction site of Arizona Power Plant

A milestone for geotechnical engineering in Guatemala was the construction of the Arizona Power Plant, where two ground improvement techniques were used for first time. The project is locate near Puerto Quetzal in the alluvial plains of the Pacific coast prone to a high seismic risk. Its construction started in 2002 using a direct foundation solution, after the floor slab was poured significant settlements were observed. In order to improve the ground condition, initially a High Dynamic Compaction and e-quake drains treatment were proposed and implemented. This was the first time that high dynamic compaction have been used in Guatemala, and the treatment was performed by ITSA a local contractor, Figure 2.13 shows the site after high dynamic compaction performance and before e-quake drains installation. This treatment did not improved the deep ground against liquefaction risk, so an alternative ground improvement solution was adopted. The selected alternative was Vibroreplacement, Stone Columns, which was also the first time used in Guatemala. The solution consisted of 13.00 m depth stone columns and was performed by Hayward Baker the American subsidiary of the British company Keller.

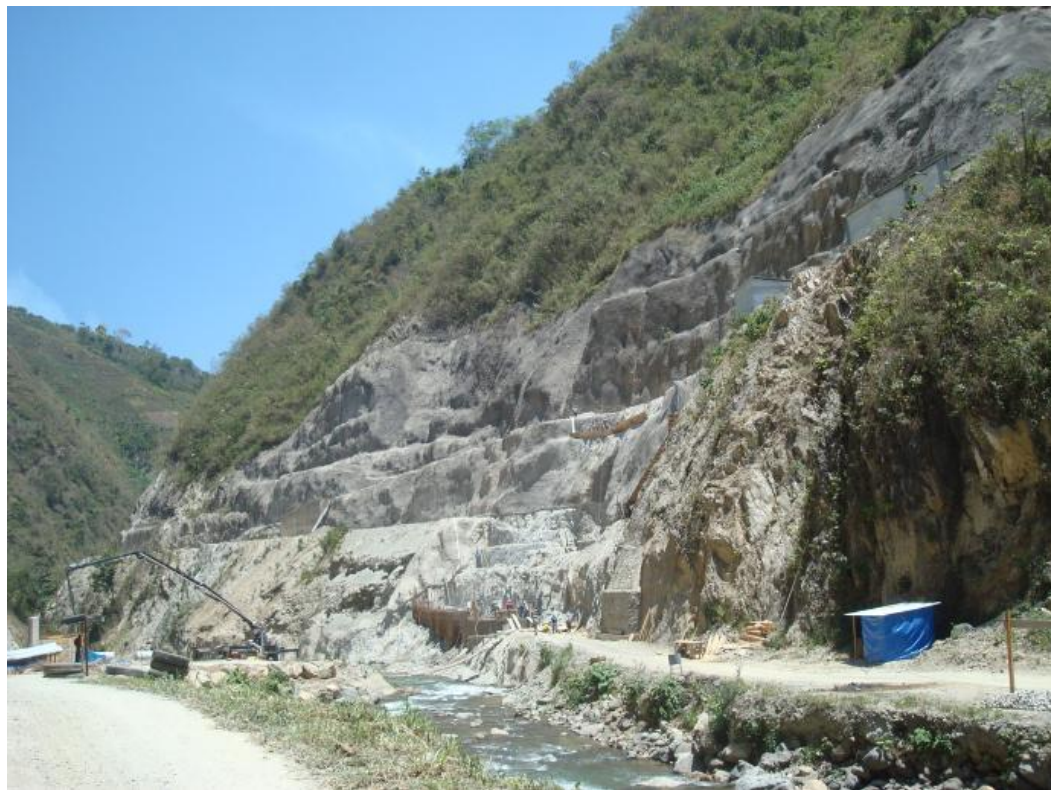
Figure 2.14. Construction site of Santa Teresa Dam

The Santa Teresa dam part of the Hydro-electric power project in 2010 brought a new era in the performance of grouting in Guatemala. In order to control seepage under the dam a grouting curtain was installed. It included the implementation of Grouting Intensity Number method, (GIN) also the first time that this method was used in Guatemala, Figure 2.14 shows the dam construction.

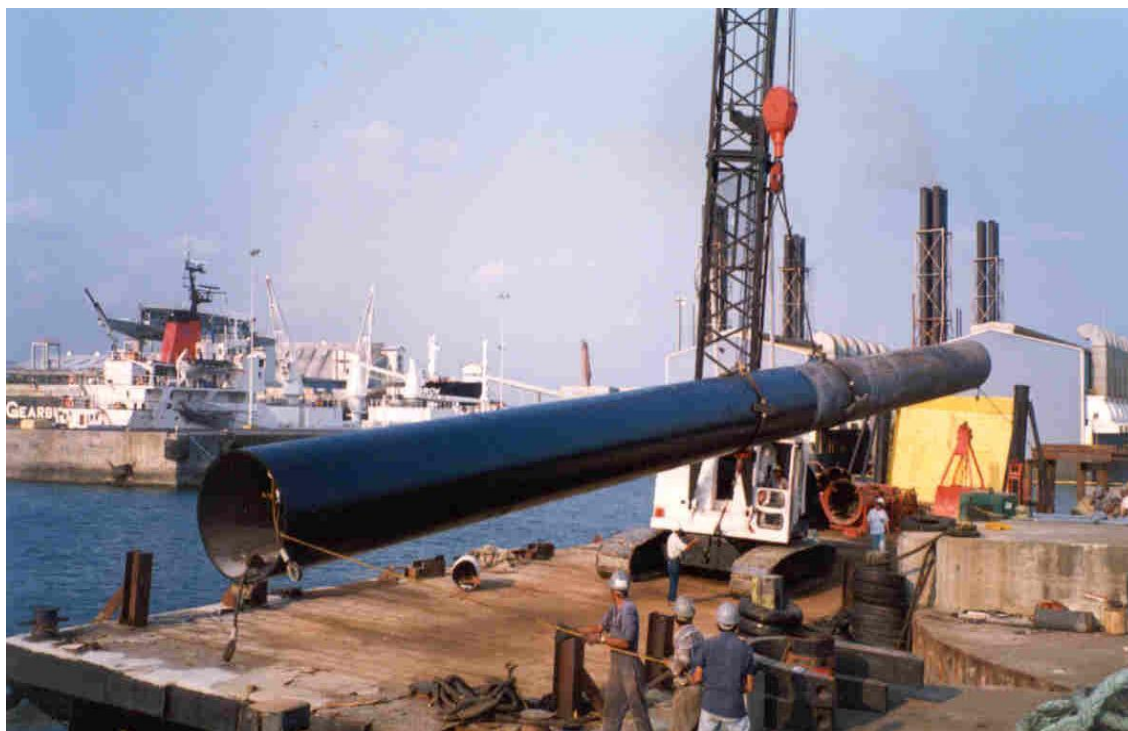
Figure 2.15. Steel piles of Barcaza Man

Puerto Quetzal is the most important marine project performed since 1955, according with the web site of Empresa Portuaria Quetzal. It was built from 1980 to 1983 by the French company Dragages Et Travaux Publics. The wharf consists of a sheet pile wall with a concrete slab in the top. It was the first time that a structure of this type was built in Guatemala. For its construction a small railroad was built in order to ease concrete blocks and rocks transportation. The other relevant projects are San Jose docking station and Barcaza Man Power Station this project are part of thermal electric power plants. Both were the first to use large diameter steel driven piles, 1.50 m. Both were performed from 1999 to 2000 in Puerto Quetzal harbor area by Swissboring Overseas Corp. Ltd. Figure 2.15 shows the handling of the steel piles of Barcaza Man and Figure 2.16 show the pile driving process of the steel pipe piles of San Jose Docking station.

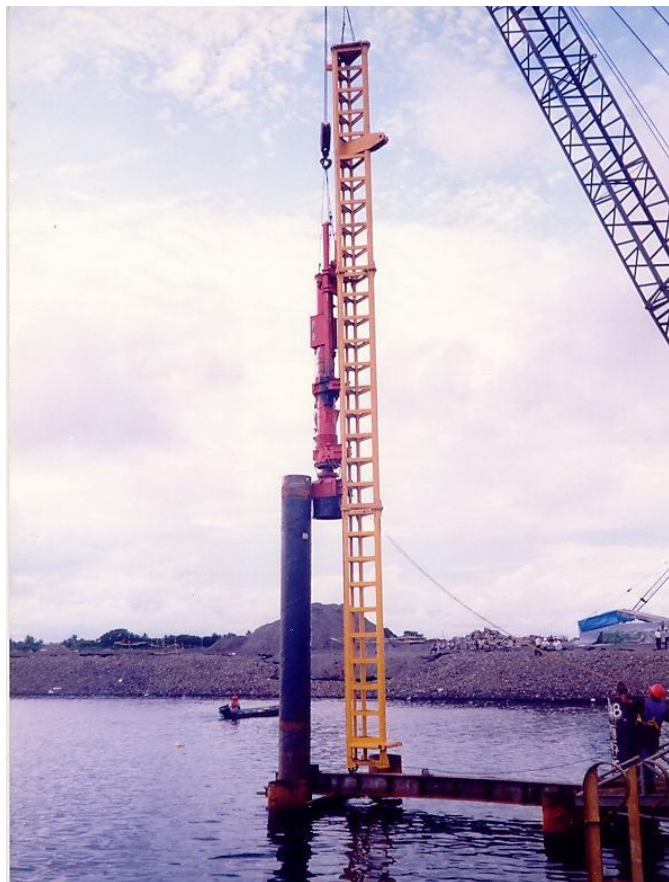
Figure 2.16. Construction of San Jose Docking Station

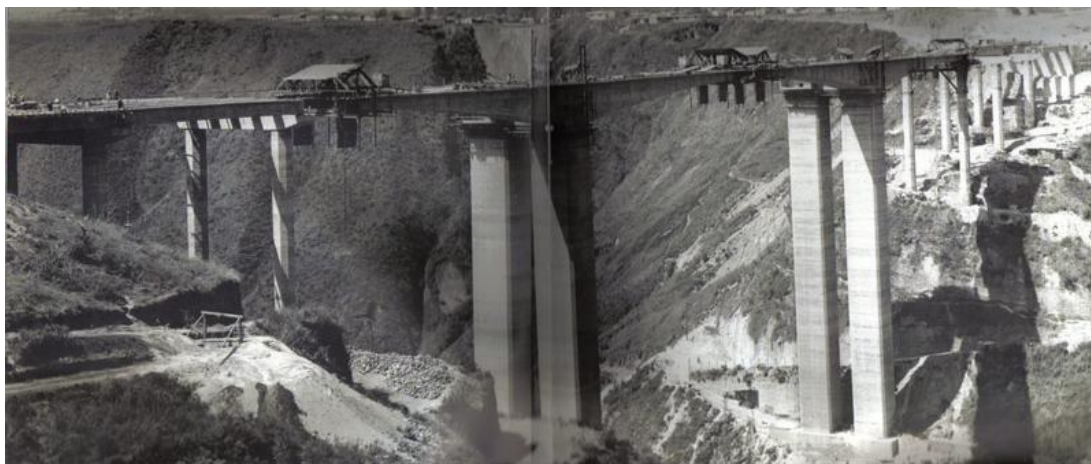
Figure 2.17. Construction of Incienso Bridge deck (Castillo, 2009)

The Incienso bridge, Ingeniero “Martín Prado Vélez” bridge, is the second largest bridge in Guatemala and was the first one to use a post-tensioned box girder system, its construction started in 1973 was inaugurated on June 1974. This is also one of the largest bridges in Central America with a total length of 390.00 m, a width of 25.00 m and height from the bottom of the creek to the deck of 135.00 m. It was built by Ingenieros Urruela y Sittendfeld, Cía. Ltda. from Guatemala, and Ingenieros Civiles Asociados, S. A., ICA, from Mexico (Arriola, J., 2007), Figure 2.17 and 2.18 shows different construction stages.

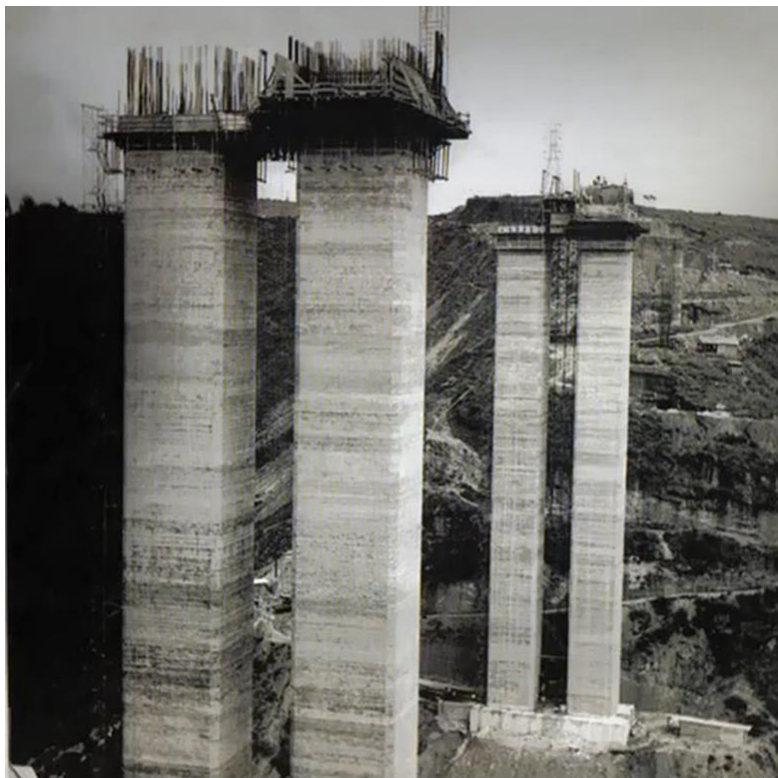
Figure 2.18. Construction of Incienso Bridge piers (Rodas, 2012)

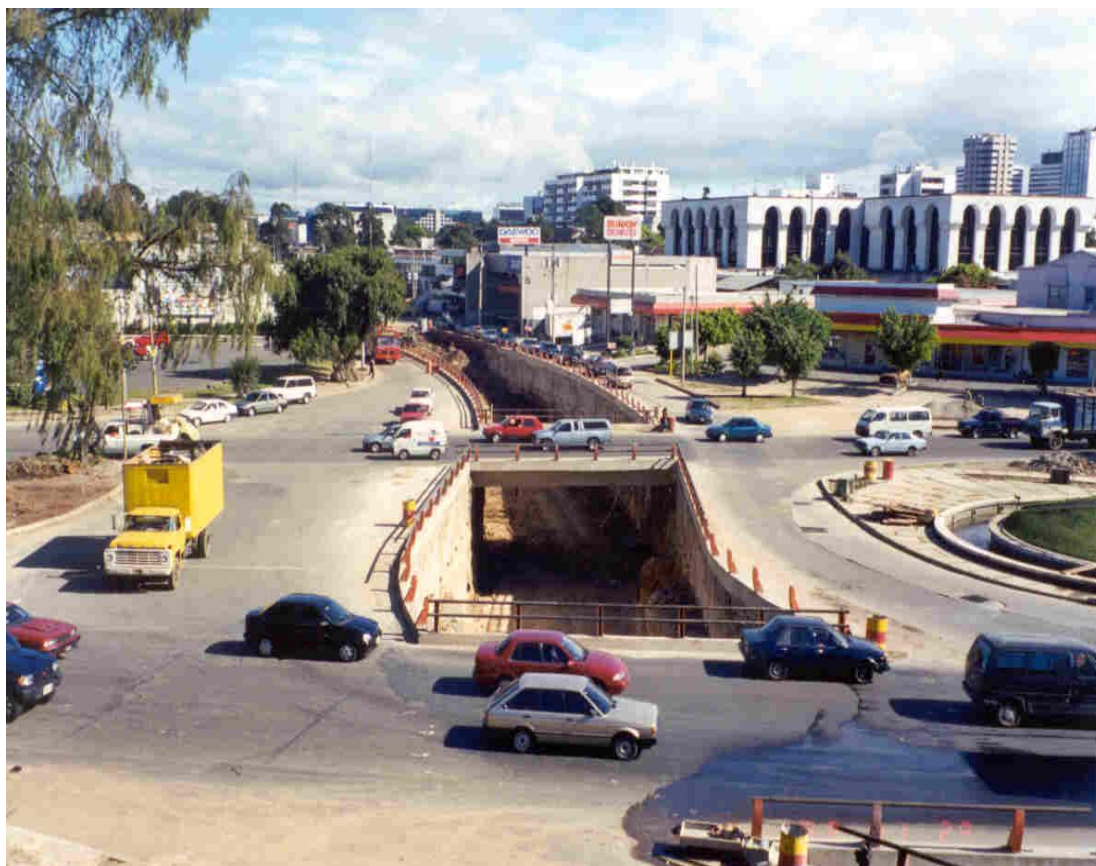
Figure 2.19. Construction of Reloj de Flores Underpass

The bridges over Guacalte and Achiguate Rivers where built in 1999 as the first to use foundation drilled piers built in the alluvial plains. The Reloj de Flores underpass was built in 1999 and includes the construction of the first diaphragm wall in Guatemala, also post-tensioned anchors were used to support the wall. The underpass required a diaphragm wall because the area used to be a lagoon that was filled for the construction of the La Liberación Boulevard, Figure 2.19 shows the excavation stage.

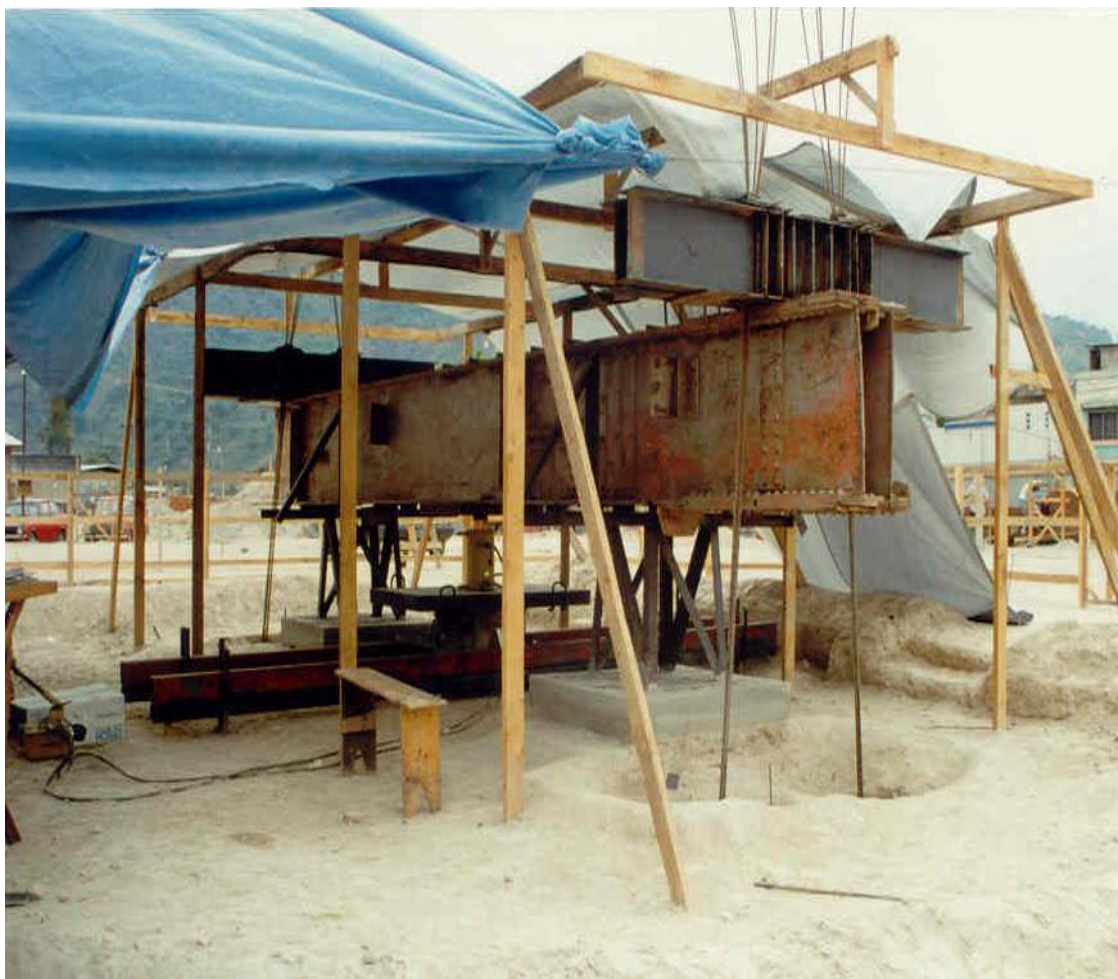
Figure 2.20. Pile load test in Cementos Progreso Cement Plant

The clinker silo construction in 2000 of the Cementos Progreso cement plant in Sanarate included the performance of the first loading test. The load test was a full scale test of 1.20 m diameter drilled pier, using posttensioned anchors as reaction, Figure 2.20 shows the test setup. The test, anchors and pile construction were performed by Swissboring Overseas Corp. Ltd with advice of CPK a Salvadorian consultant firm. Other milestone of piling is also provided by Cementos Progreso in its new San Juan cement plant where 7 load tests were performed using Osterberg Load Cells. The test were performed by the American company Load Test meanwhile the piles were performed by Rodio-Swissboring Figure 2.21 shows drilled shafts and load cells installation.

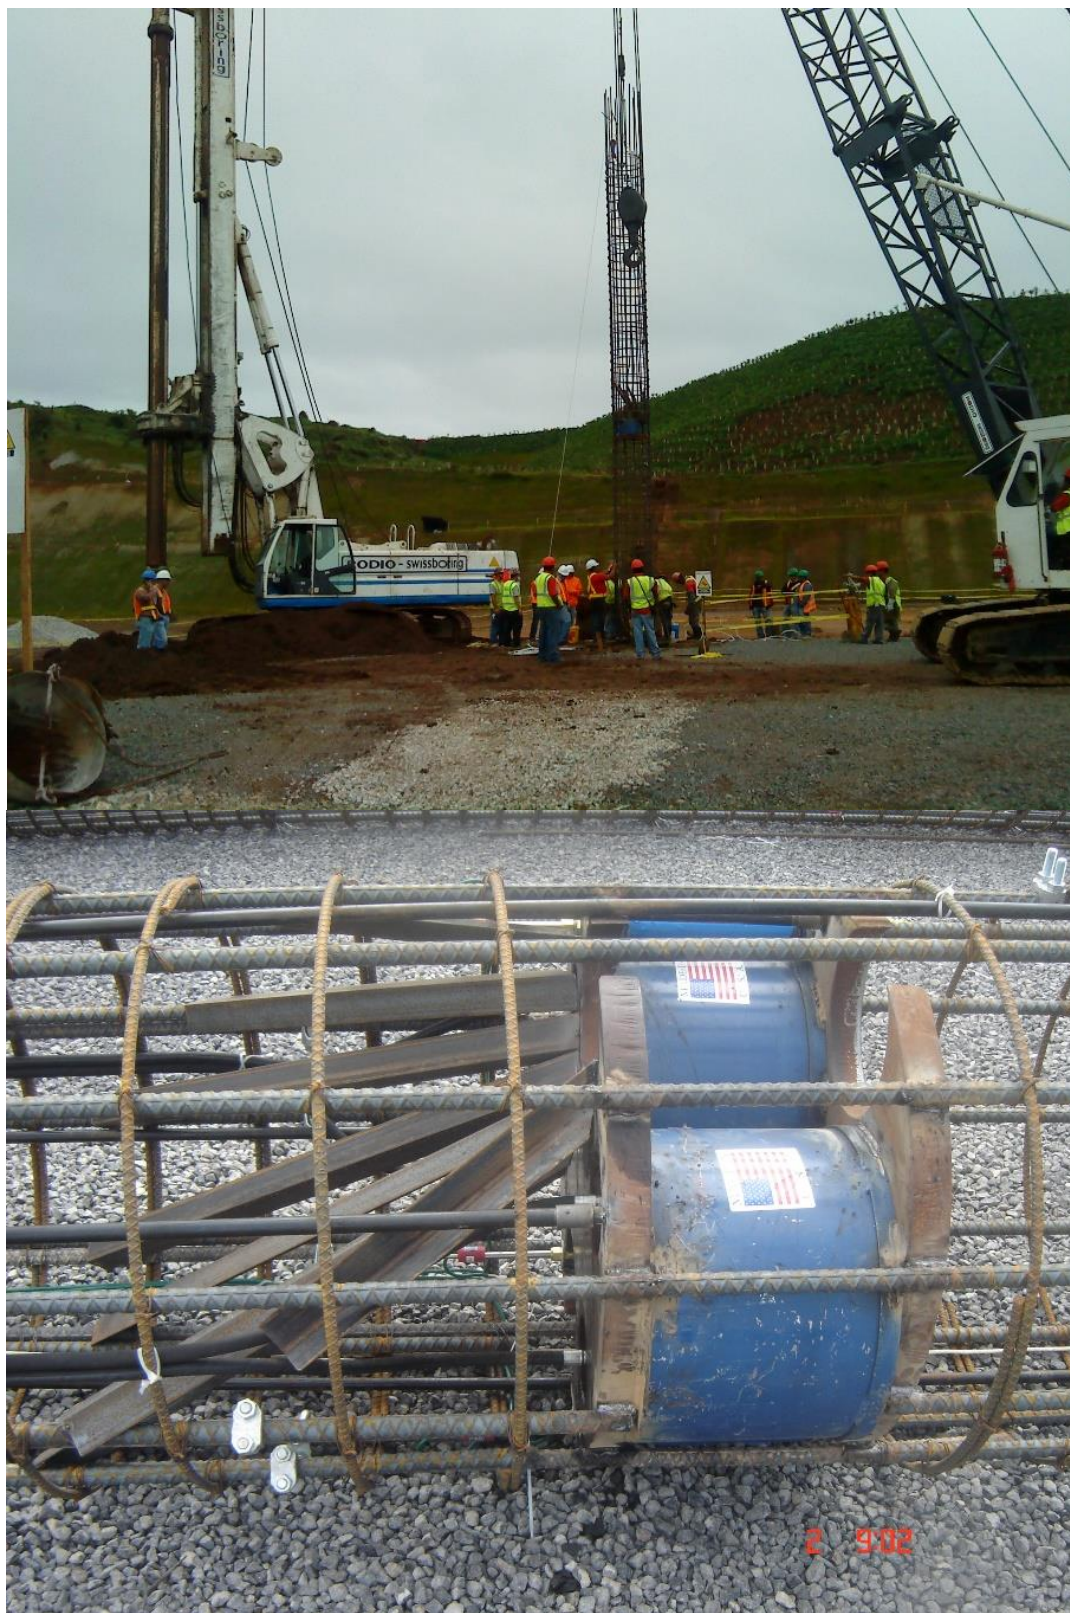
Figure 2.21. Drilled shaft load test of San Juan Cement Plant

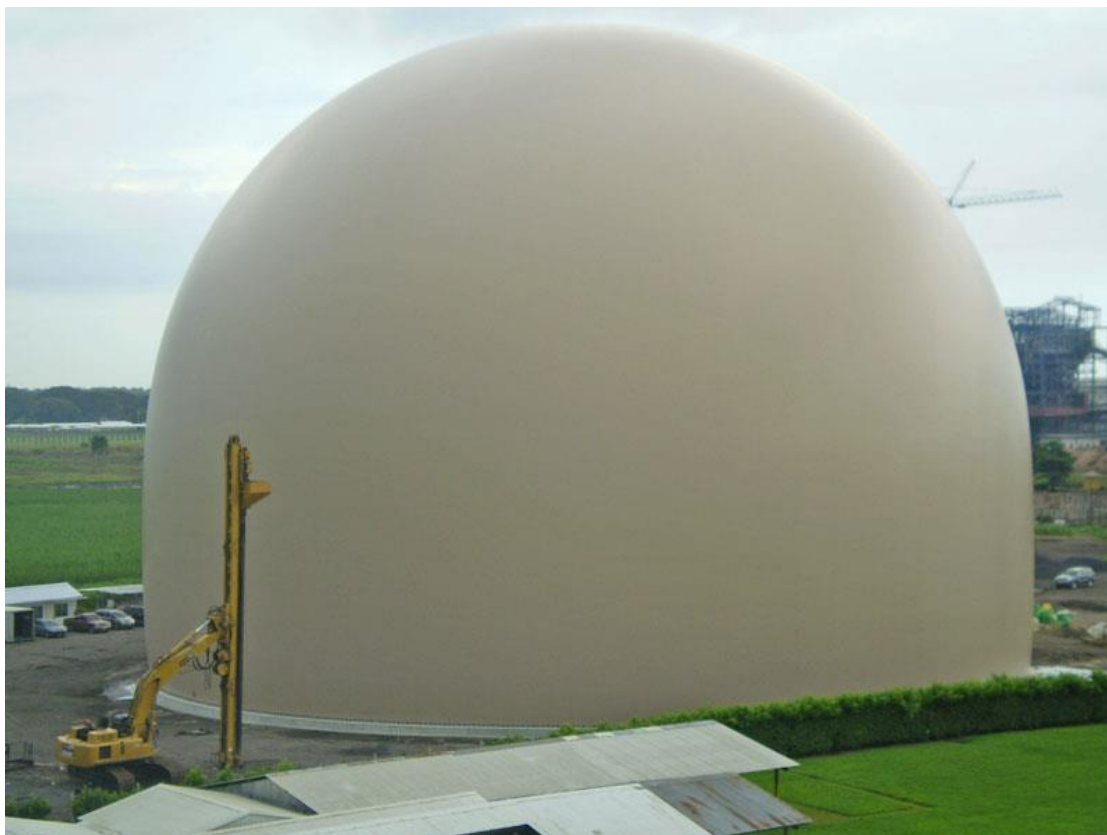
Figure 2.22. Magdalena Sugar Storage Facility (Soiltec, 2012)

The construction of the shotcreted dome of the Magdalena sugar production facility in 2012 by Soiltec was relevant for geotechnical engineering because it was the first time that rammed aggregate piles were used in Guatemala. Figure 2.22 shows the inflatable form for the dome construction and the rammed aggregate pier equipment mounted on a conventional track-mounted excavator.

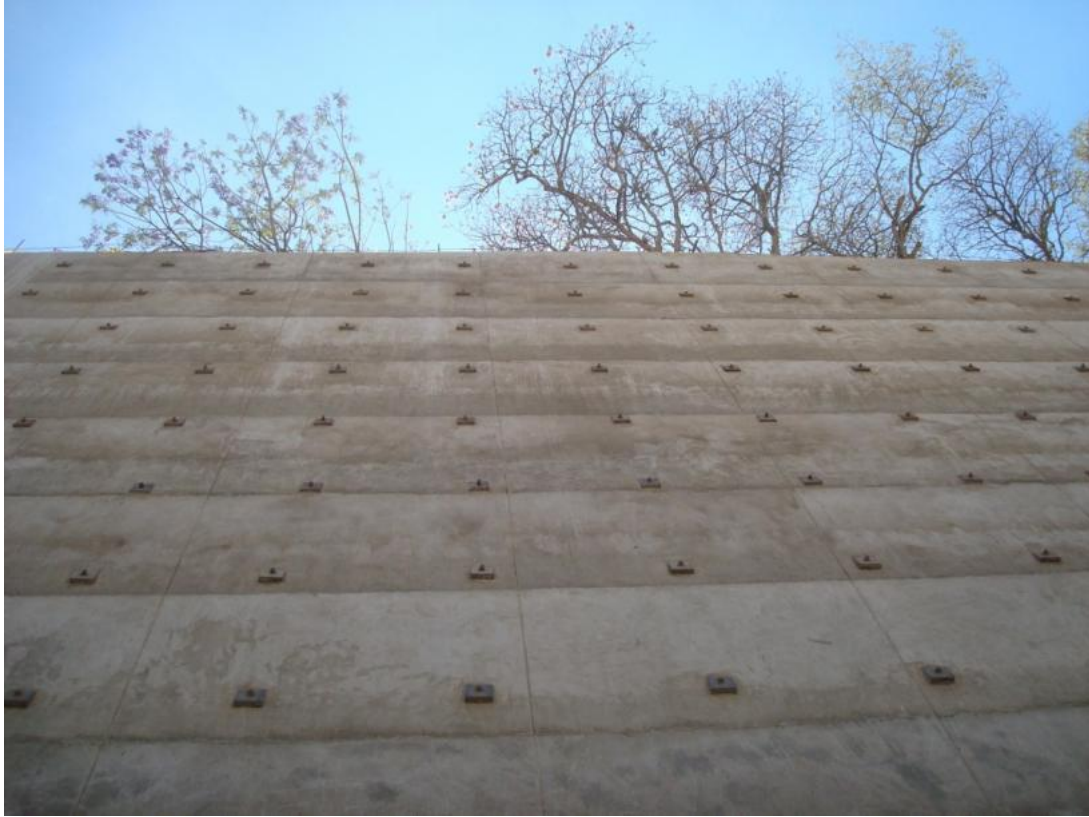
Figure 3.1. Vertical soil nailing wall for excavation stabilization

The Figure 3.1 shows a vertical soil nailing wall for a basement construction.

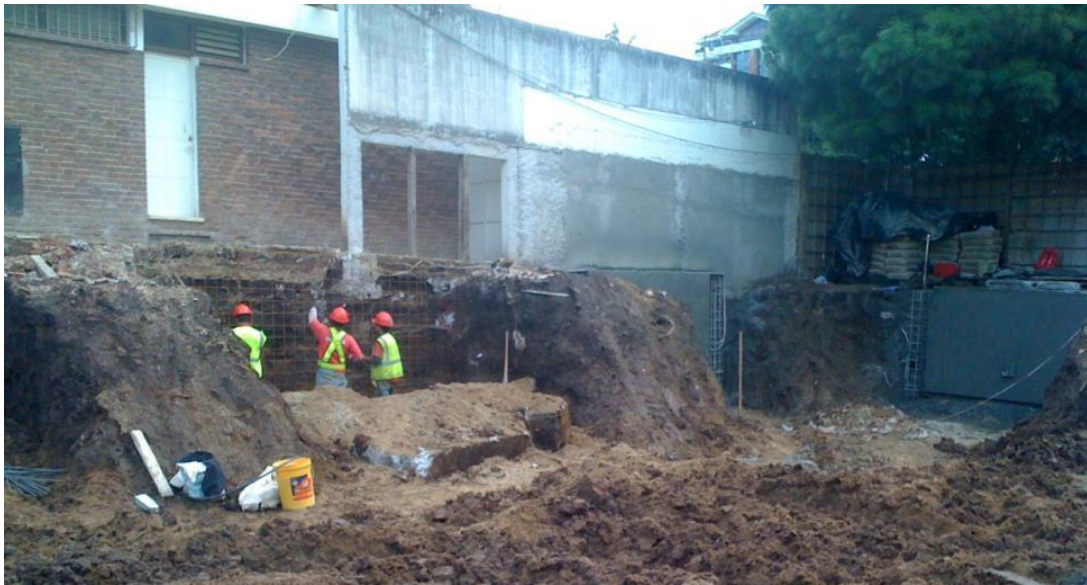
Figure 3.2. Berm utilization during construction

3.1.3.1. Ground conditions. The most important ground condition for soil nail walls performance is the temporary stability during each excavations stage, normally 24 to 72 hour. Is recommended do each stage with some alternates berms as shown in the Figure 3.2.

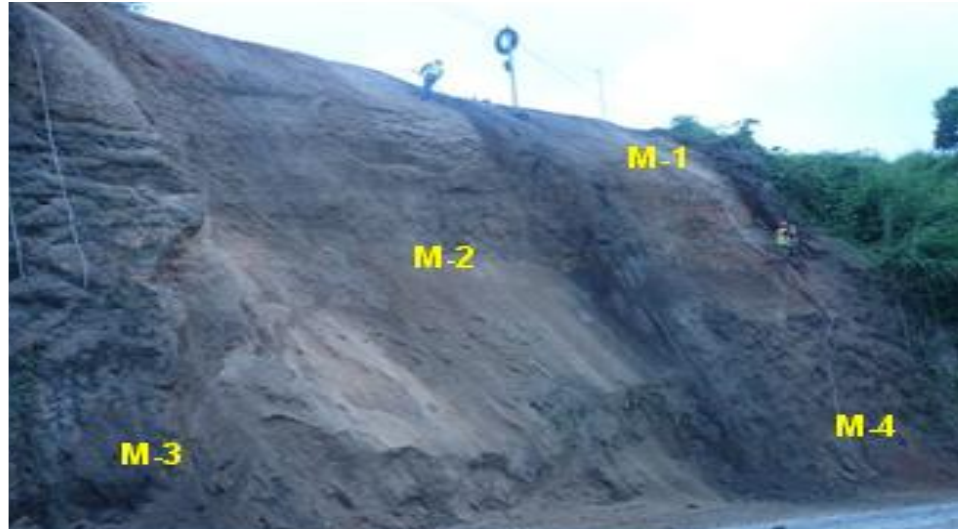
Figure 4.4. Slope face with sampling location

4.1.2.3. Geotechnical investigation. To investigate the surface and subsurface conditions at the site a geotechnical field program was planned. The field geotechnical survey consisted of two boreholes of 23.00 m depth with core recovery and performing Standard Penetrations Tests (SPT) at 1.00 m intervals and four block samples. The four block samples were taken from the slope face and were taken to the laboratory for direct shear testing, Figure 4.4 shows the sampling activities. Boreholes were drilled using wire line system (HQ diameter; 96.5 mm outside diameter; 63.5 mm sample diameter) as shown in Figure 4.5 for borehole 2. Boring logs and core boxes photos are included in the appendices. Figure 4.6 shows the borehole locations.

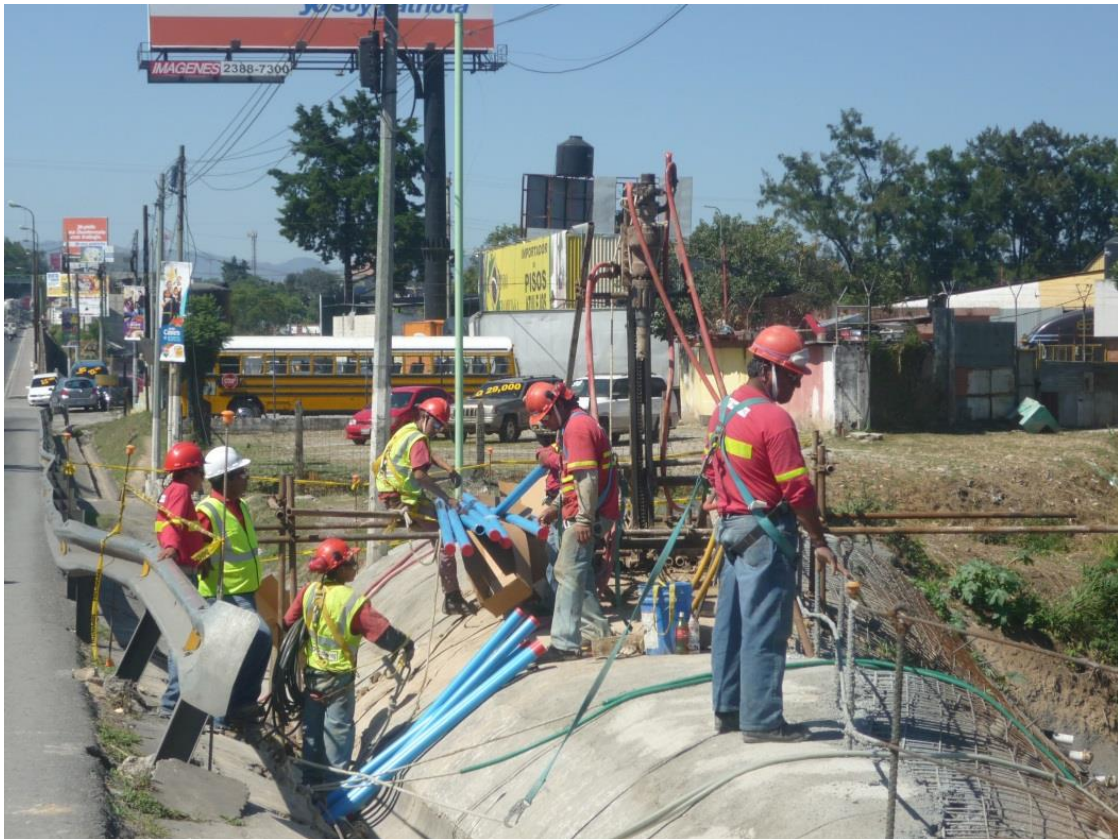
Figure 4.14. Inclinometer installation

4.1.6.1. Instrumentation. Inclinometers were installed at three different locations in order to monitoring slope and soil nailing walls movements, Figure 4.14 shows an inclinometer installation. The Table 4.3 shows inclinometers characteristics. Readings were performed with a digital inclinometer and Figure 4.15 shows technicians conducting the inclinometer readings. Inclinator system characteristics are shown in the Table 4.4. Digipro software was used to analyze the information. The monitoring program includes the reading of the inclinometer during one year period, in order to have a more complete data of the performance of this wall, Table 4.5 shows the monitoring schedule. Additional readings were conducted in 2015 to examine the long-term performance of earth structures.

4.1.5.1.5. Instrumentation. Inclinometers were installed at two different locations of the slope, one with 23.0 m length and other with 11.0 m length. Pipe of 70 mm diameter was used.

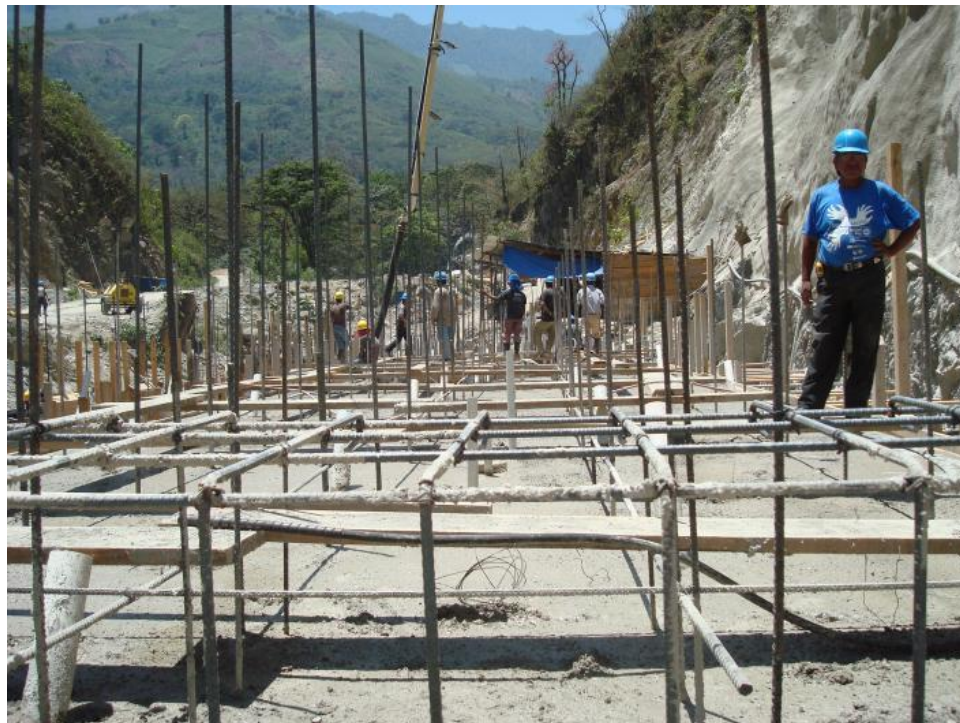
Figure 4.28. PVC sleeves intalled during construction

4.2.5.1. Sleeve installation. In order to reduce drilling and possible damage to the concrete of the dam a 10 cm diameter PVC sleeves were installed in the base of the dam during the initial construction stage. Figure 4.28 show PVC sleeve installed during construction.

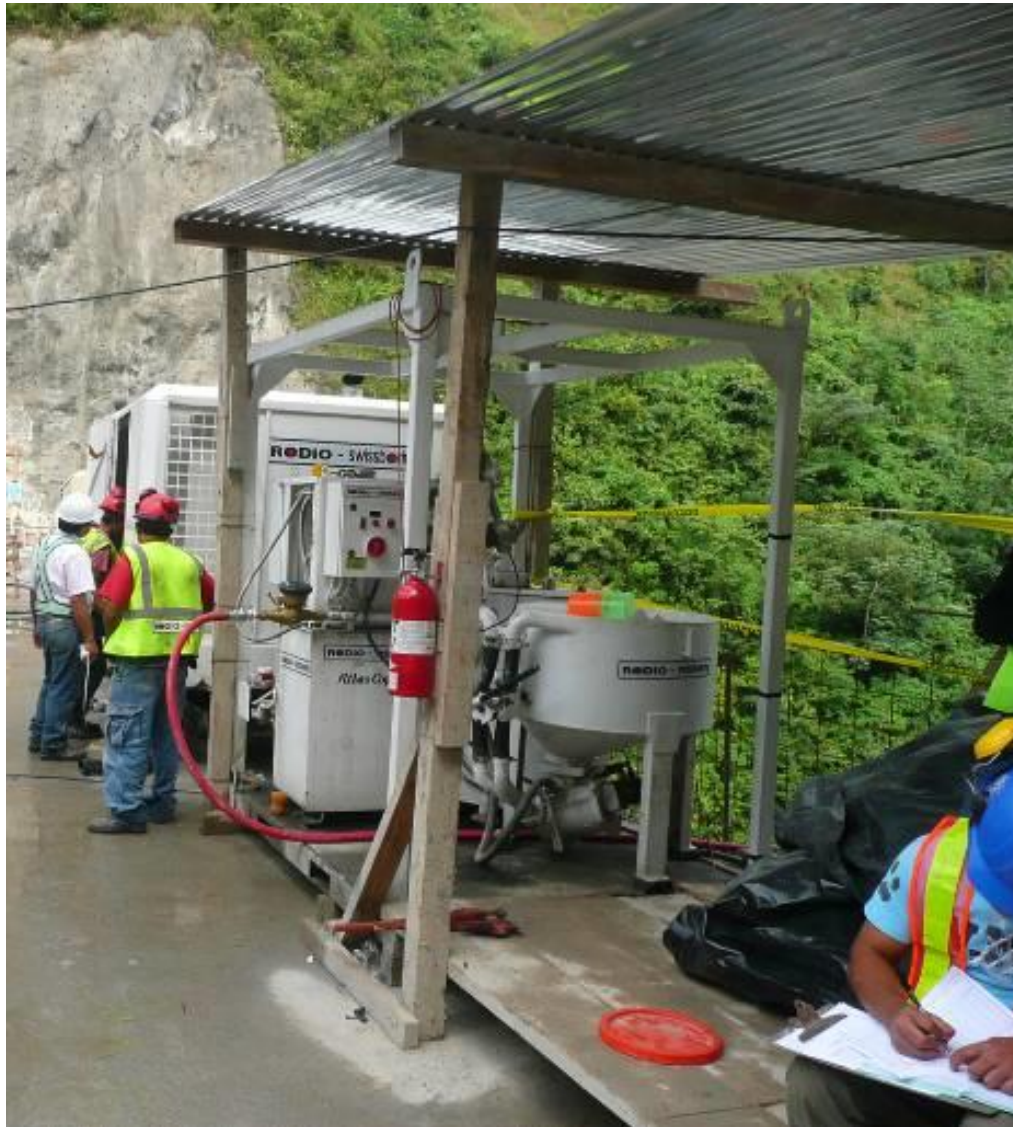
Figure 4.29. PVC sleeves installed during construction

4.2.5.2. Grouting station set-up. Grouting stations were located in strategic points to reduce pumping distance as well as to ease grouting works. During the set-up of the grouting station a foreign technician from the grouting monitoring manufacturer, Jean Lutz, came to the project to perform the initial equipment calibration. This calibration included pressure, volume, grouting rate, stoppage parameters. Figure 4.29 shows one of the two grouting stations.
